# EVALUATION OF BEHAVIOR OF BUILDINGS IN CHANGUREH—AVAJ EARTHQUAKE STRICKEN REGION

H. Shakib\*, M. Ahmadizadeh\* and M. Rashtian\*

## ABSTRACT

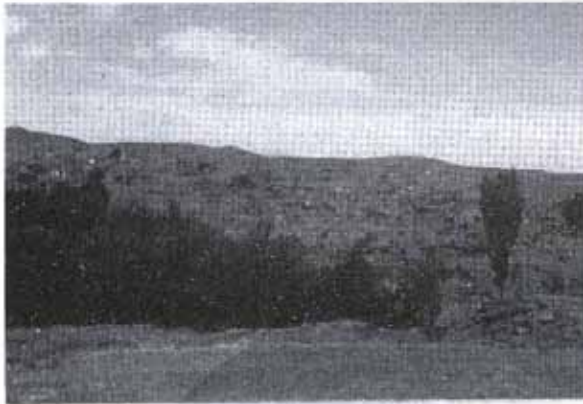
**Fig. 7: Complete failure of adobe buildings in Abdarreh**

Figures 7 and 8 show complete collapse of this type of buildings in Abdarreh and Changureh villages. A two-story adobe building that did not completely fail is shown in Figure 9. This may be a result of the soft soil the building is constructed on, which reduces the energy transferred to the structure. Figure 10 shows these buildings adjacent to some engineered masonry buildings that did not collapse.

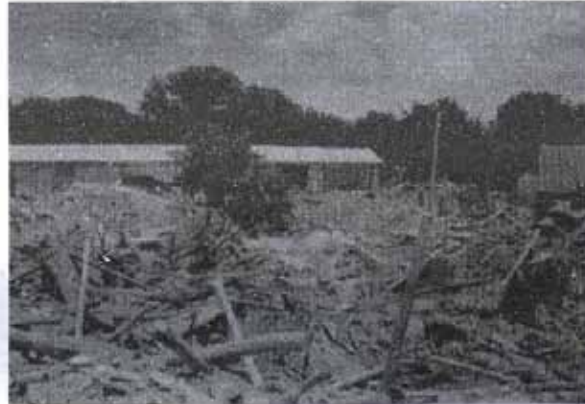
**Fig. 8: Complete failure of adobe buildings in Changureh**

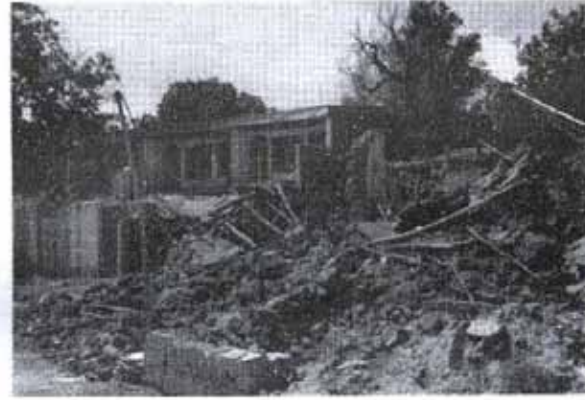
**Fig. 10: Collapsed non-engineered buildings beside engineered ones**

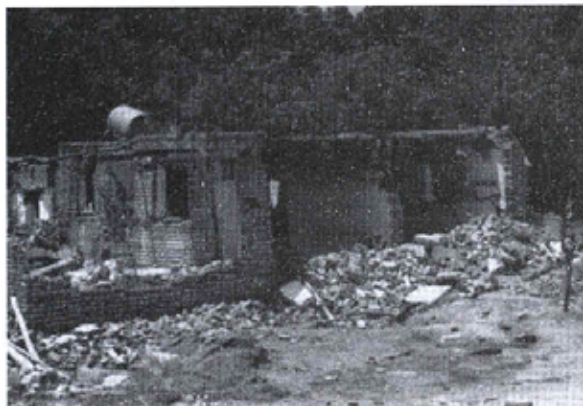
**Fig. 11: Damaged brick masonry building**

A non-engineered brick masonry building is illustrated in Figure 11, which failed due to weak materials, large openings, absence of ties and non-symmetric stiffness distribution in plan. Figure 12 shows a destroyed jack arch roof of a masonry building. Insufficient bracing and weak mortar can be the causes of this defect.

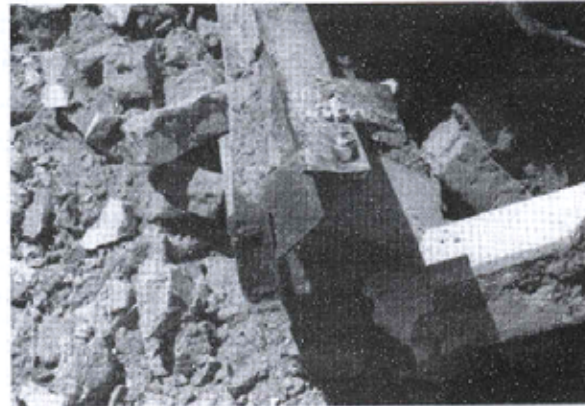
**Fig. 12: Failed jack arch roof**

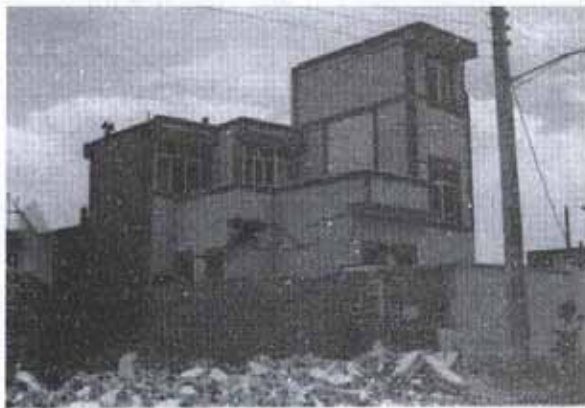
Fig. 13: 3-story steel frame building damaged due to high torsional forces

Figure 13 shows a 3-story steel building in Avaj, which is severely damaged due to large torsional forces generated during the earthquake. The system is non-symmetric both in plan and in elevation. Some completely collapsed buildings are illustrated in Figures 14 and 15. Their system was simple steel frames without bracing.

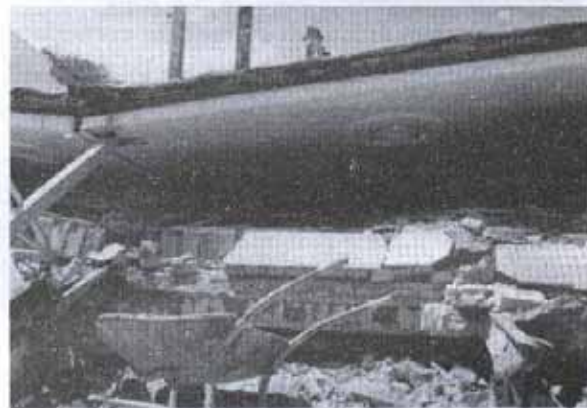
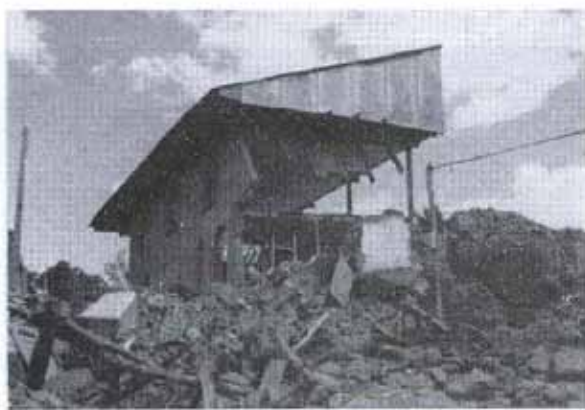
Fig. 14: Collapsed simple steel frame building

Fig. 15: Collapsed simple steel frame building

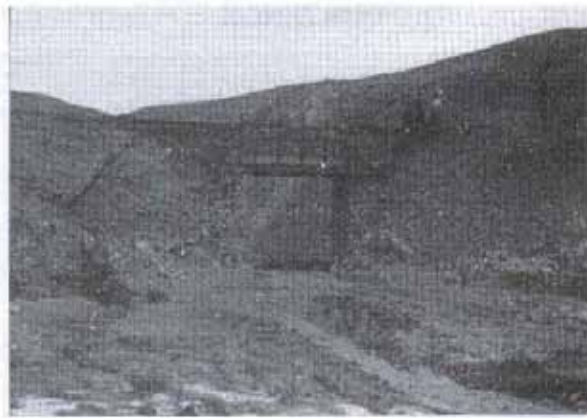
Fig. 16: Changureh entrance bridge

Figure 16 shows the entrance bridge to Changureh that is damaged along with, a nearby temporary road is constructed for transportation. Figure 17 illustrates a wall, which is cracked horizontally because of construction discontinuity. Failure of a weak beam-column connection is shown in Figure 18. In this connection, the continuous beam is crossed through the column and a single angle profile on each side serves as a seat for the beam.

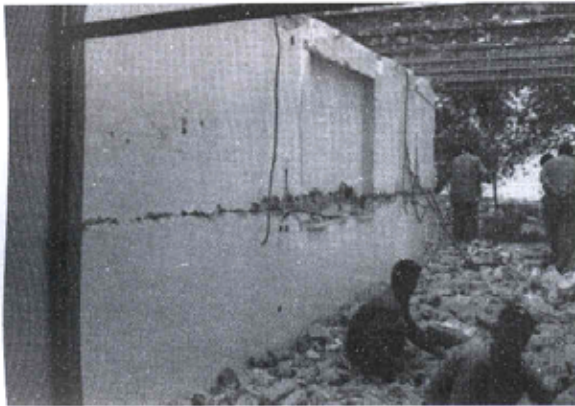
Fig. 17: Cracked wall due to construction discontinuity

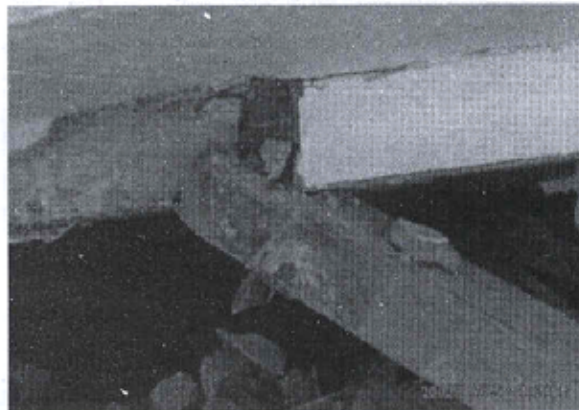
Fig. 18: Weak connection between beam and column
