# EVALUATION OF BEHAVIOR OF BUILDINGS IN CHANGUREH—AVAJ EARTHQUAKE STRICKEN REGION

H. Shakib\*, M. Ahmadizadeh\* and M. Rashtian\*

## ABSTRACT

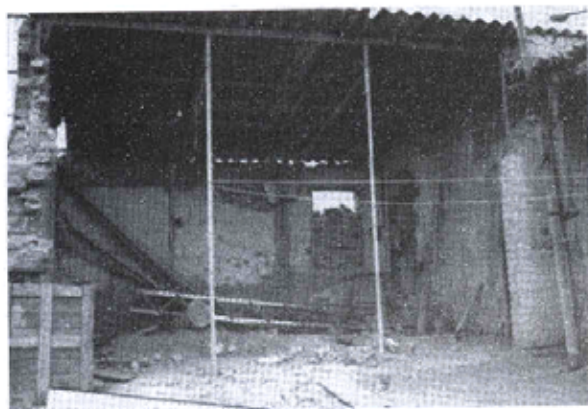
Fig. 19: Aluminum truss roof system

The aluminum truss system shown in Figures 19 and 20 is one of the building types used for rehabilitation after Booeen Zahra (1962) earthquake. This system is very light and can be an acceptable system, if architectural requirements are met.

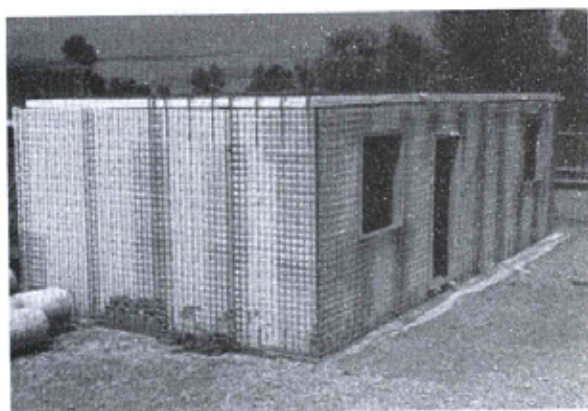
Fig. 21: Sandwich panel system

Different building systems are being used in this construction, such as steel frame system, masonry system with concrete ties or bolted steel ties, and sandwich panel system. Some of these systems are shown in the following figures (Figures 21 and 22).
